**Tree Condition Survey  
& Risk Management Plan  
for land at  
Harnham Slope, Salisbury**

**REF: ATC/TS/278**

**Date: 28<sup>th</sup> March 2014**

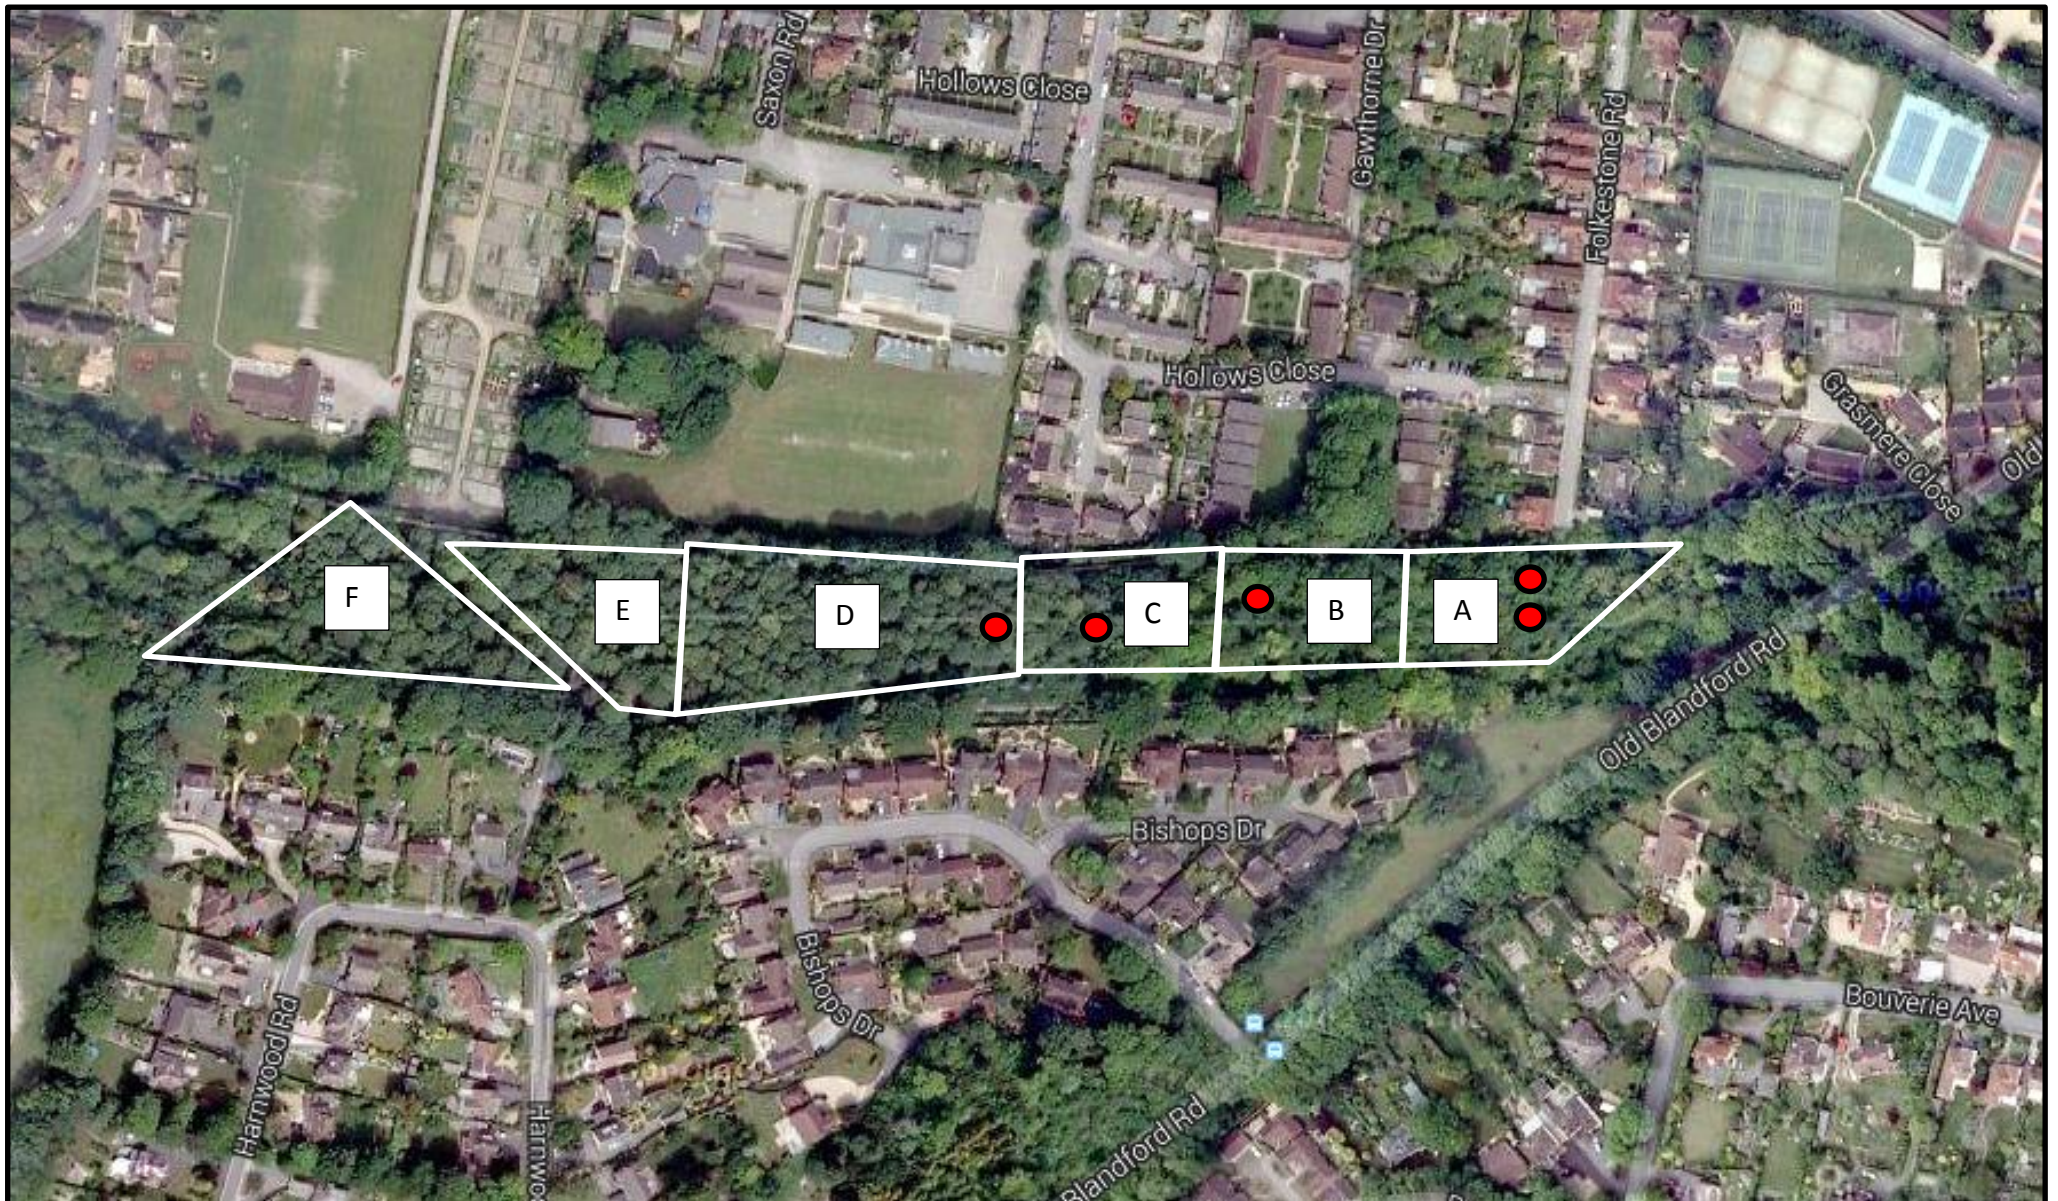
## APPENDIX F - Compartment Plan - Harnham Slope

● = Partially windthrown / snapped / hanging tree to be made safe over informal footpath (Marked with spot of blue paint on site)

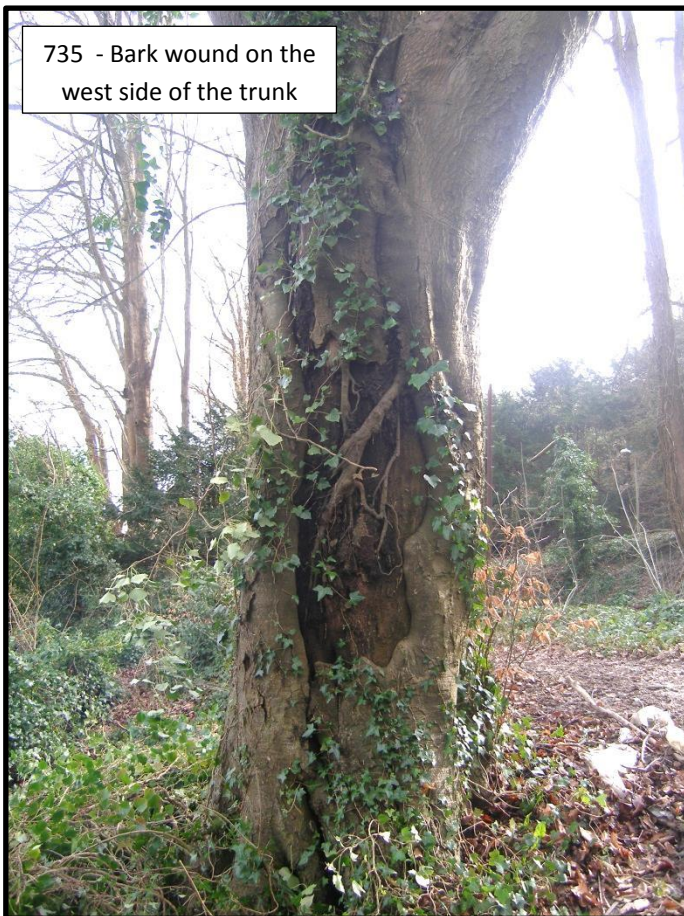
| Ref. No. | Species | Approx. Stem diam. (mm) | Phys. Cond. | Structural Condition & Comments | Management Recommendations | Priority | Wildlife Habitat Potential |
|---|---|---|---|---|---|---|---|
| 735 | Beech<br><i>Fagus sylvatica</i> | 900 | G | <ul style="list-style-type: none"> <li>Bark wound 1.5 to 2 metres in height and 60cm width on the west side of the trunk (PHOTO). The exposed wood is only superficially decayed when probed with a sharp knife. Currently poses no risk of significance to the structural integrity of the tree. Woundwood development is normal</li> <li>The trunk subdivides in to three primary stems at circa 4 metres above ground level</li> <li>Good tension unions between the north and central stem</li> <li>Compression fork between the central and southern stem with water run visible from the south-east side (PHOTOx 2 NW &amp; SE view) Region of compression extends circa 40cm on both south-east and north-west side</li> <li>Primary stem extending to the north-east over residential land is heavily laden and whilst it supports a good tension fork it has a strong lateral lean of circa 30° over a residential target area</li> <li>Crown supports occasional moderate and major deadwood over low risk area</li> <li>Light ivy growth</li> </ul> | <ul style="list-style-type: none"> <li>Selectively reduce the height and lateral branches of the stem extending north-east over residential land by up to 3 metres</li> <li>Selectively reduce the height of the branch structure from the stem extending to the south-west toward the telecoms mast compound by 2.5 metres to reduce load on the compression fork</li> <li>No works are required for the central stem</li> <li>Sever ivy to facilitate future inspections</li> </ul> | M/H | L |

735 - Bark wound on the west side of the trunk

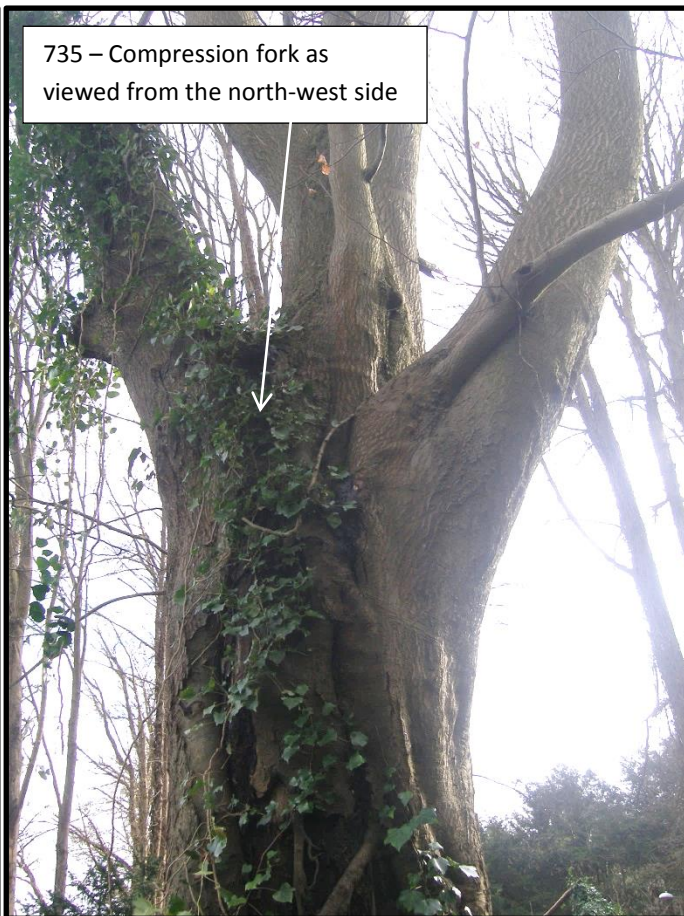
735 – Compression fork as viewed from the north-west side

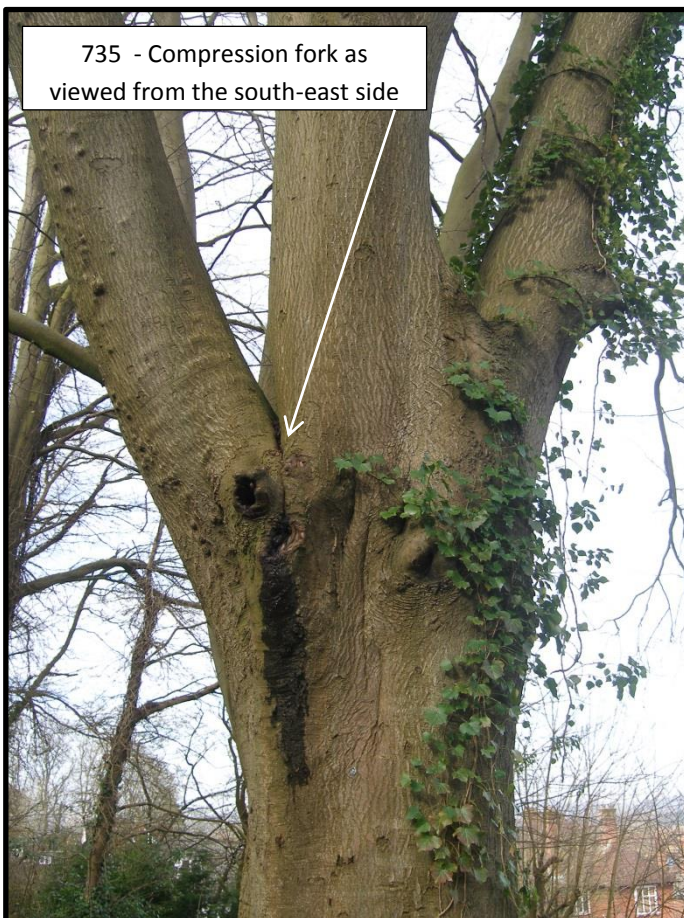
735 - Compression fork as viewed from the south-east side

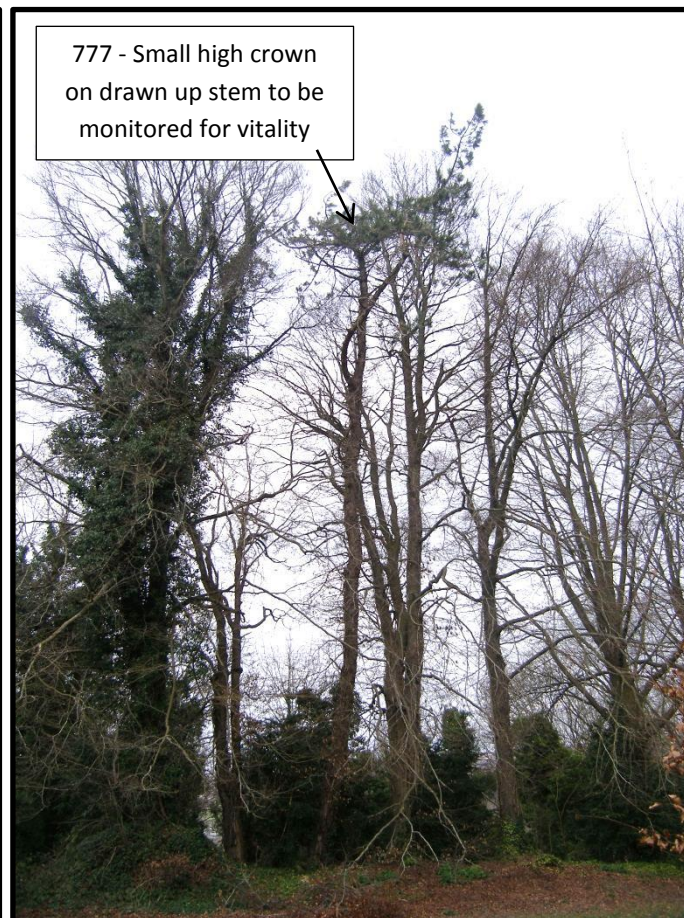
777 - Small high crown on drawn up stem to be monitored for vitality

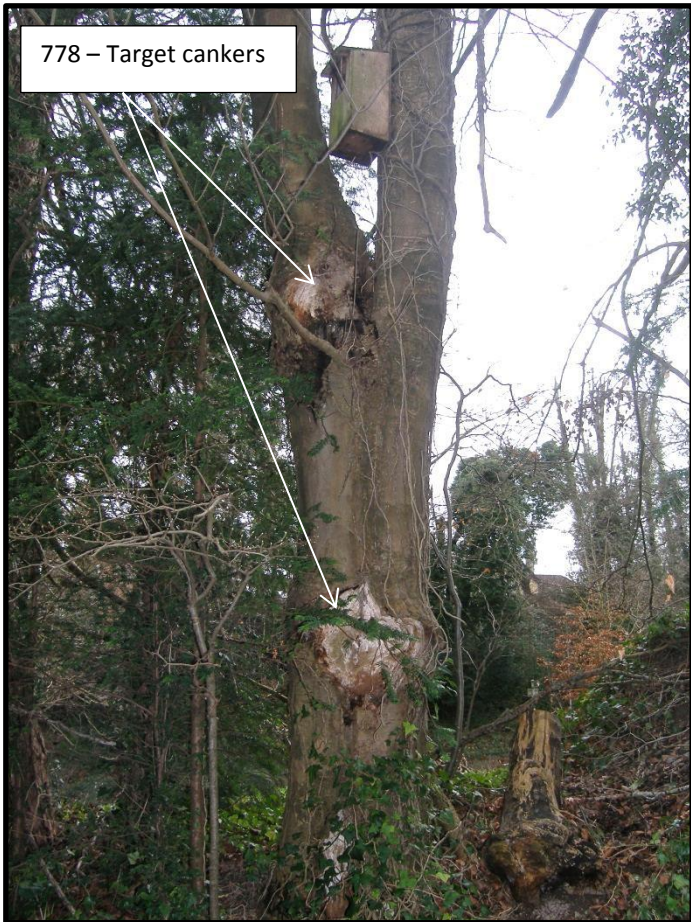
778 – Target cankers

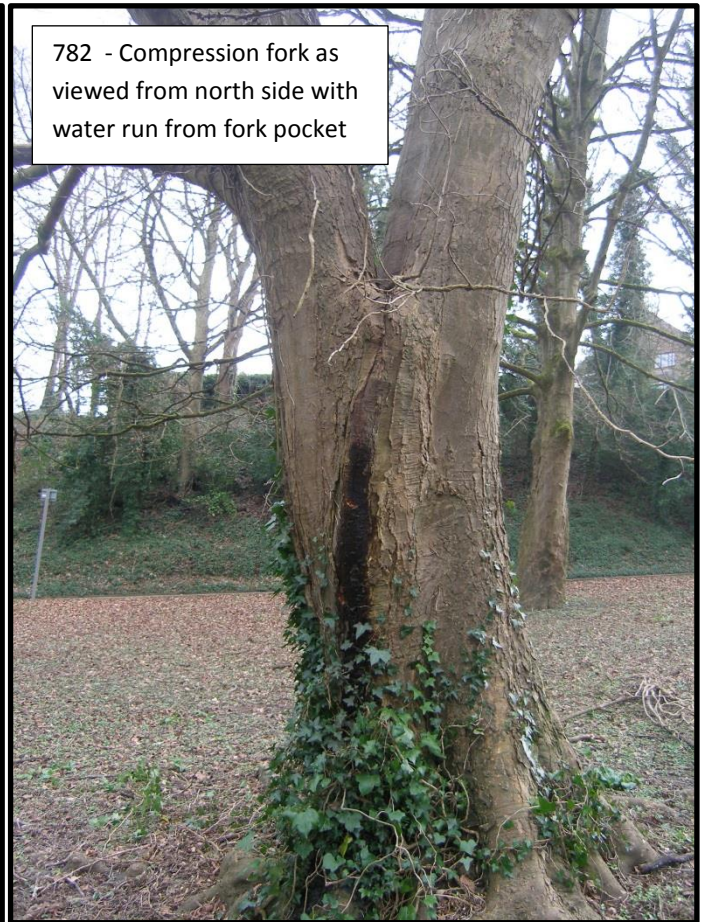
782 - Compression fork as viewed from north side with water run from fork pocket

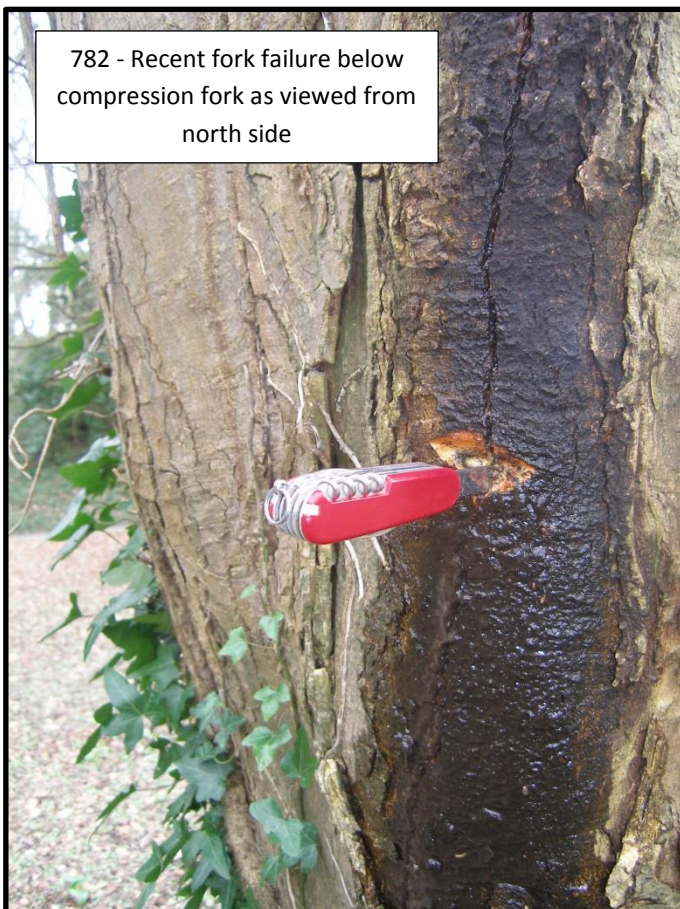
782 - Recent fork failure below compression fork as viewed from north side

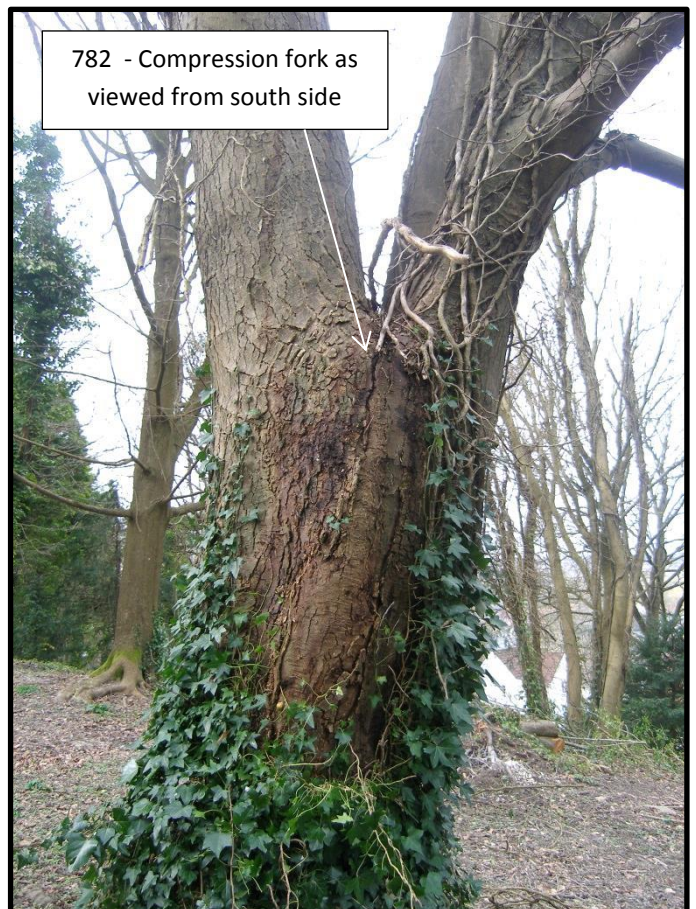
782 - Compression fork as viewed from south side

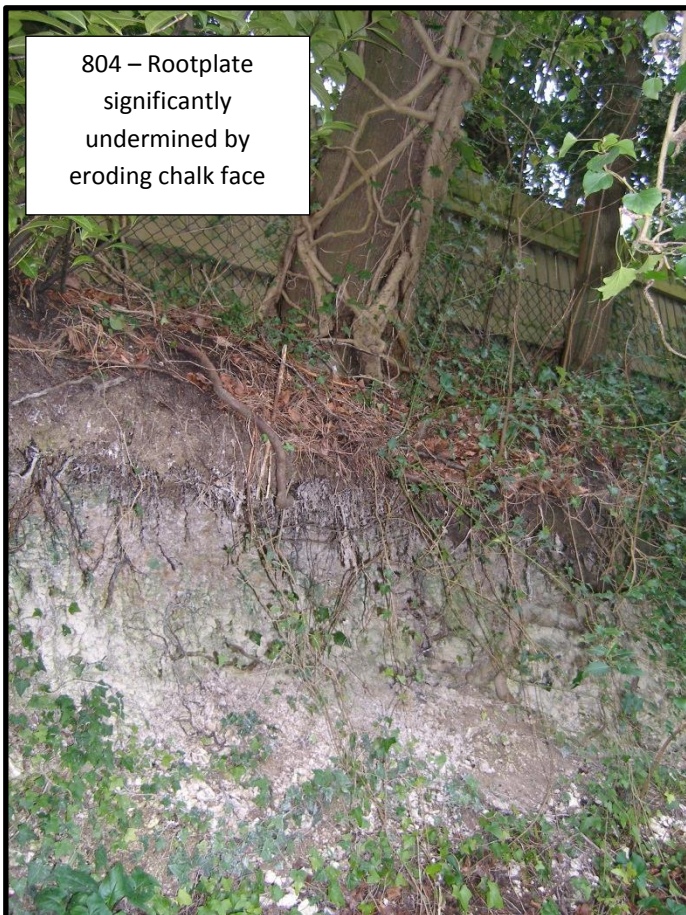
804 – Rootplate significantly undermined by eroding chalk face

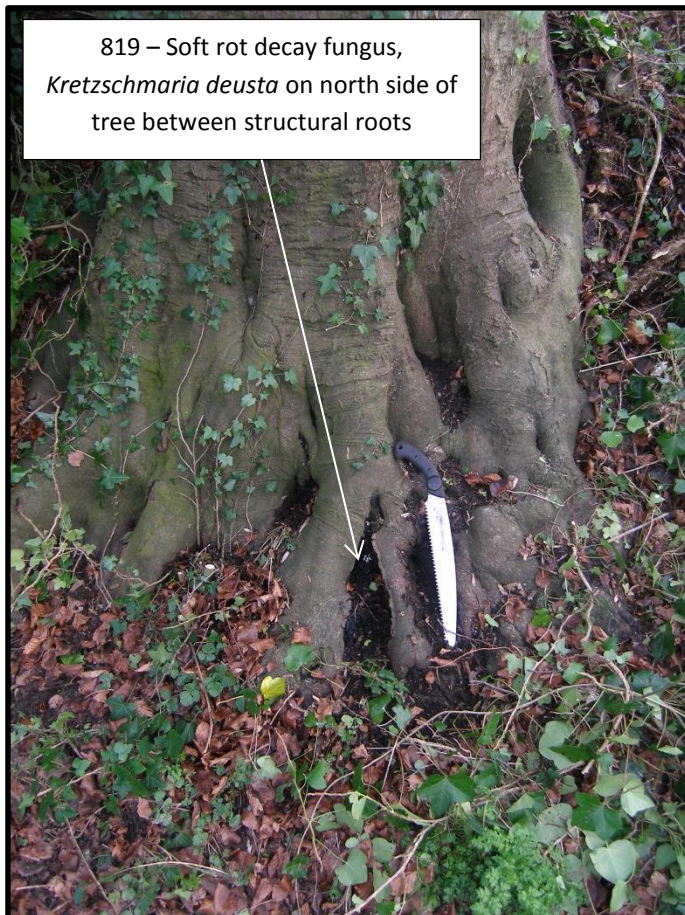
819 – Soft rot decay fungus, *Kretzschmaria deusta* on north side of tree between structural roots

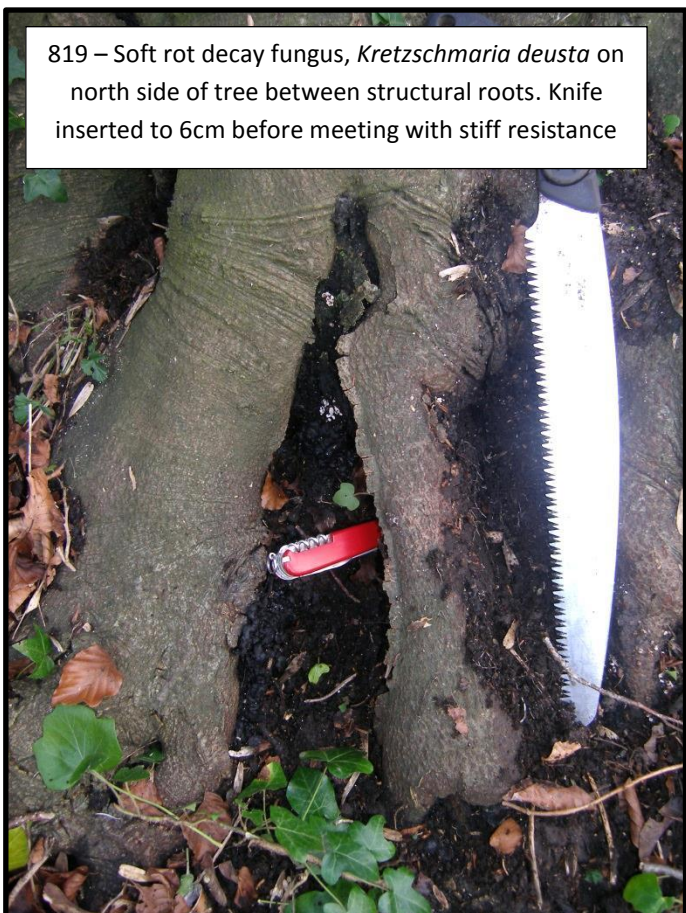
819 – Soft rot decay fungus, *Kretzschmaria deusta* on north side of tree between structural roots. Knife inserted to 6cm before meeting with stiff resistance

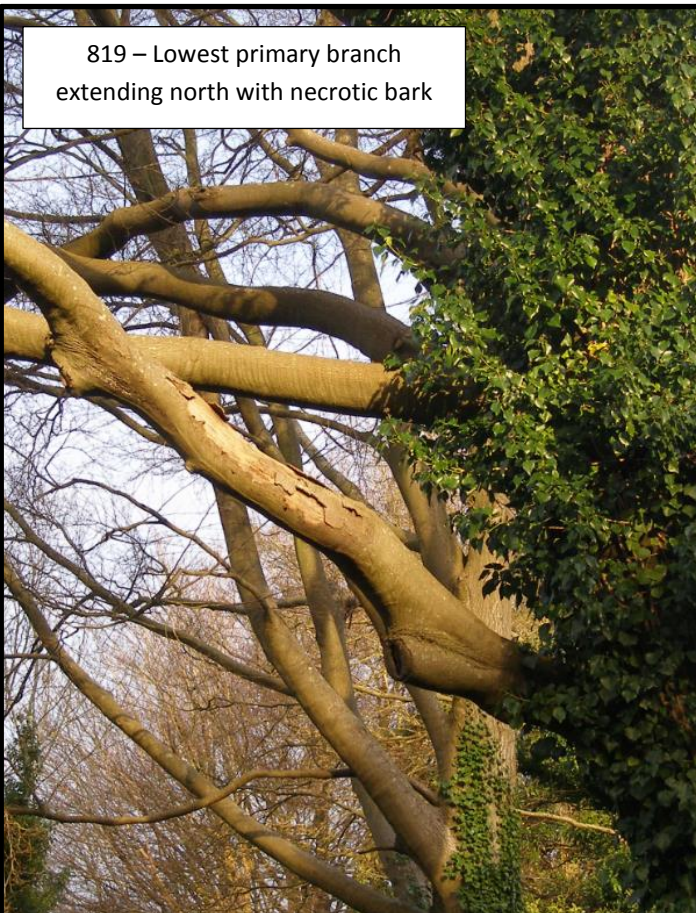
819 – Lowest primary branch extending north with necrotic bark

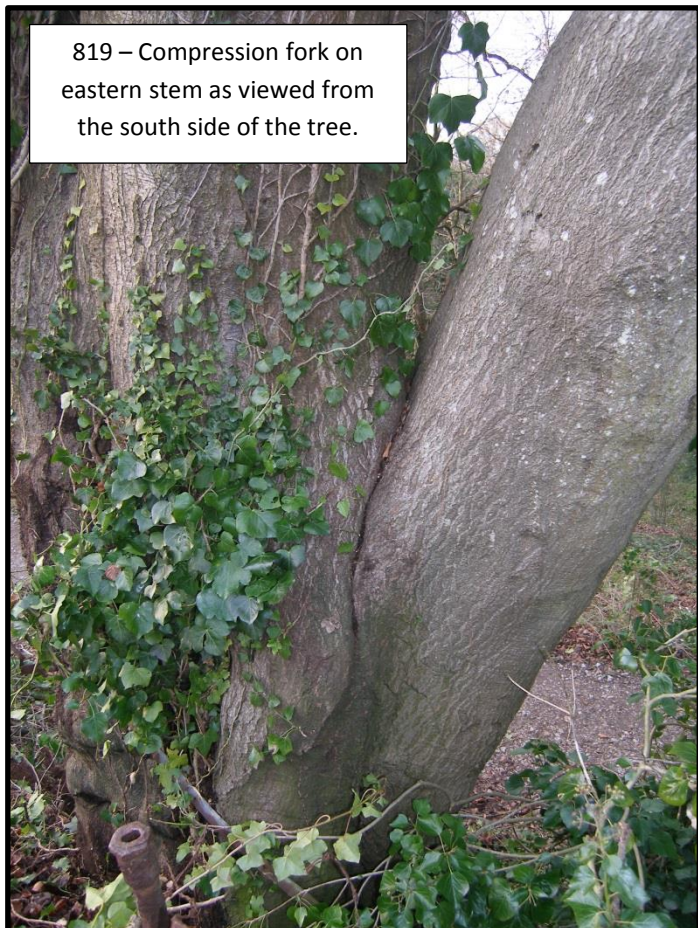
819 – Compression fork on eastern stem as viewed from the south side of the tree.

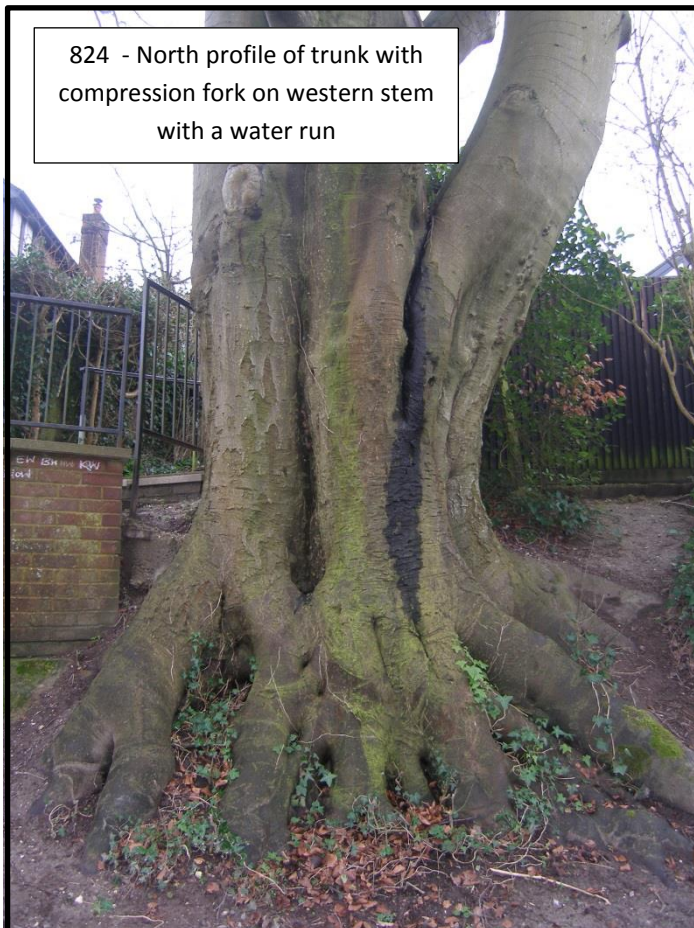
824 - North profile of trunk with compression fork on western stem with a water run

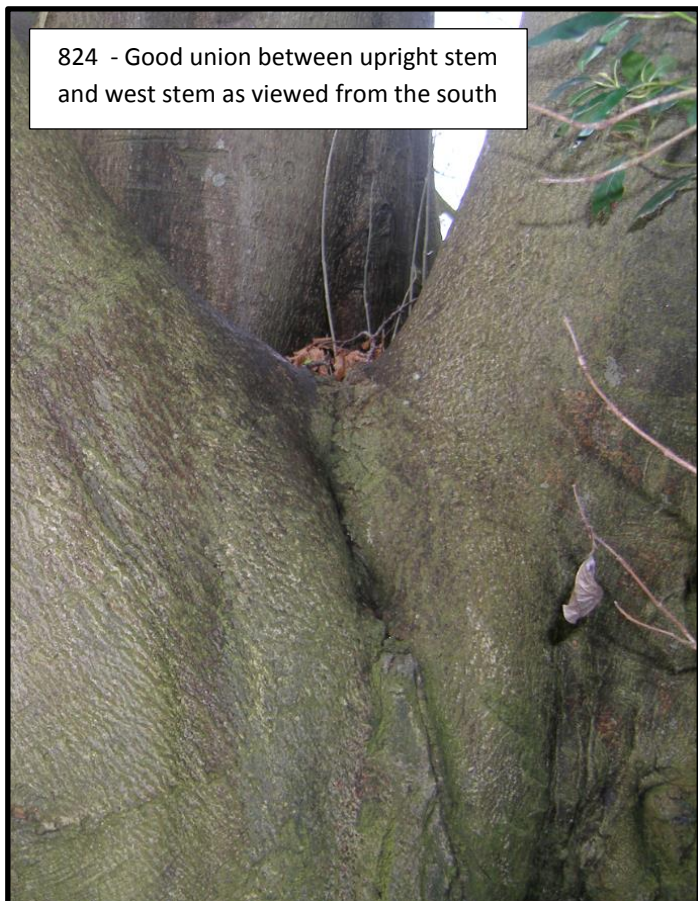
824 - Good union between upright stem and west stem as viewed from the south

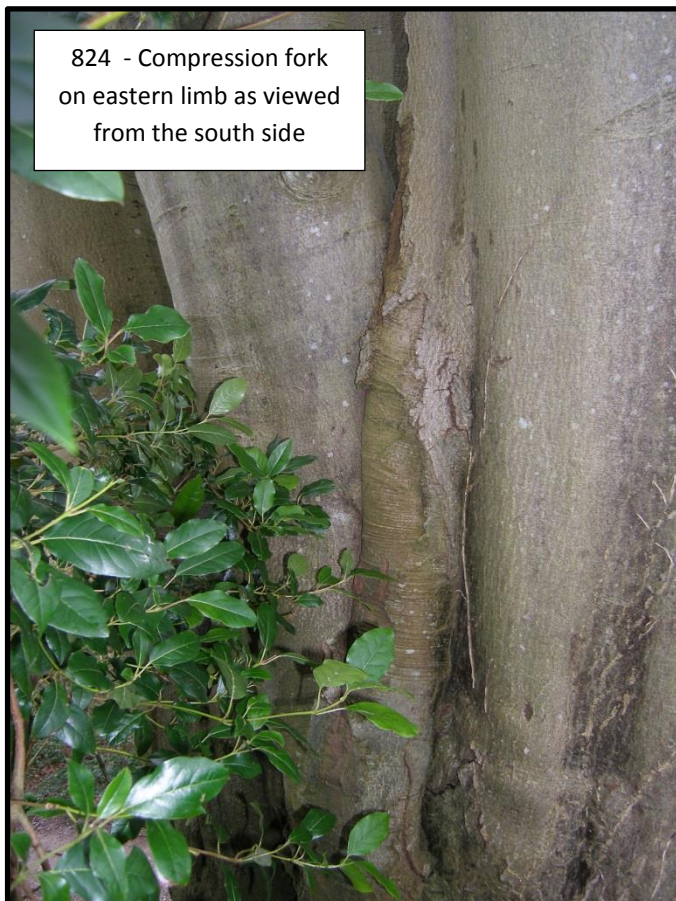
824 - Compression fork on eastern limb as viewed from the south side

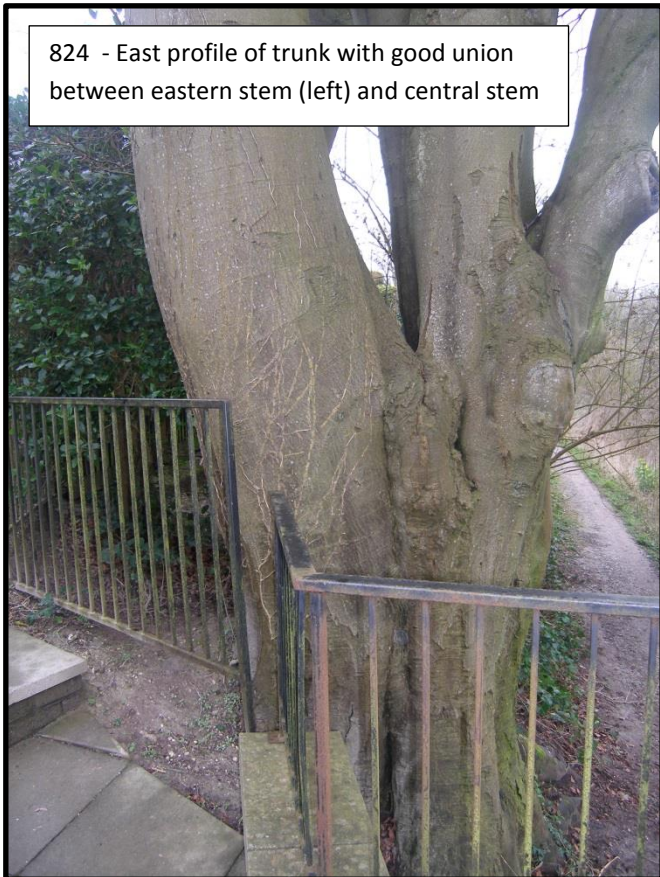
824 - East profile of trunk with good union between eastern stem (left) and central stem

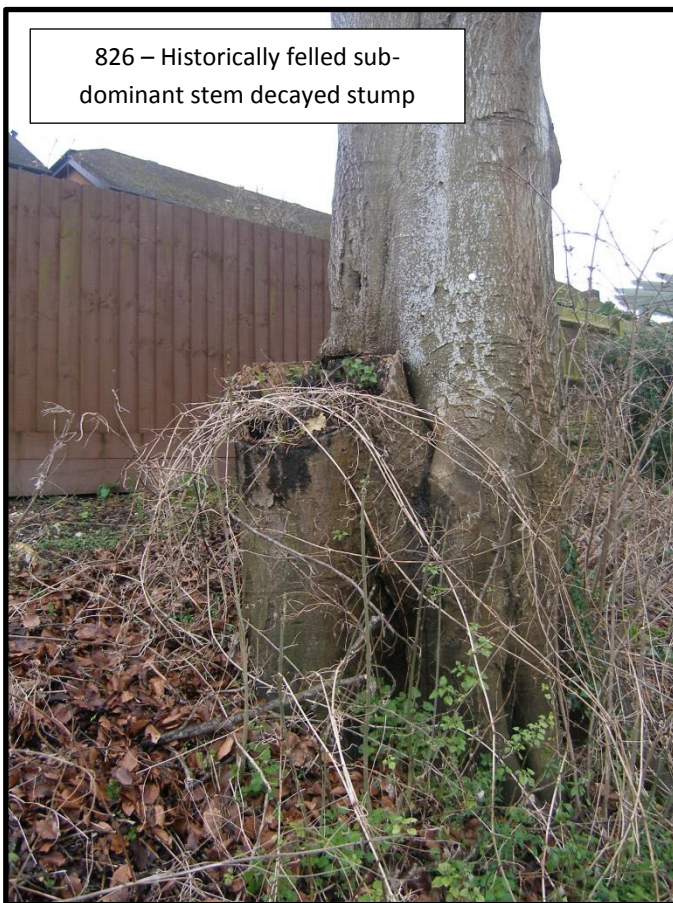
826 – Historically felled sub-dominant stem decayed stump

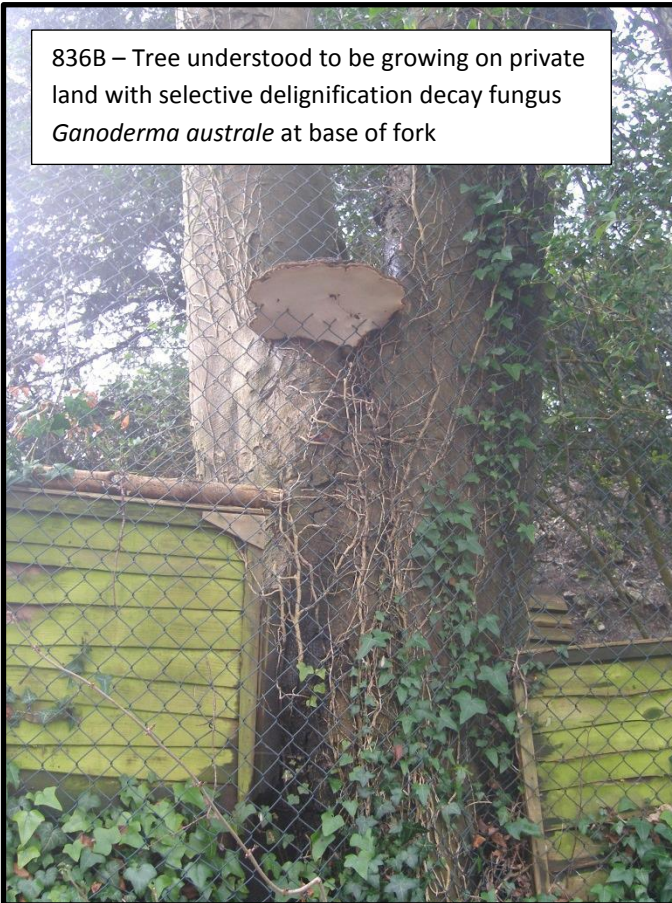
836B – Tree understood to be growing on private land with selective delignification decay fungus *Ganoderma australe* at base of fork

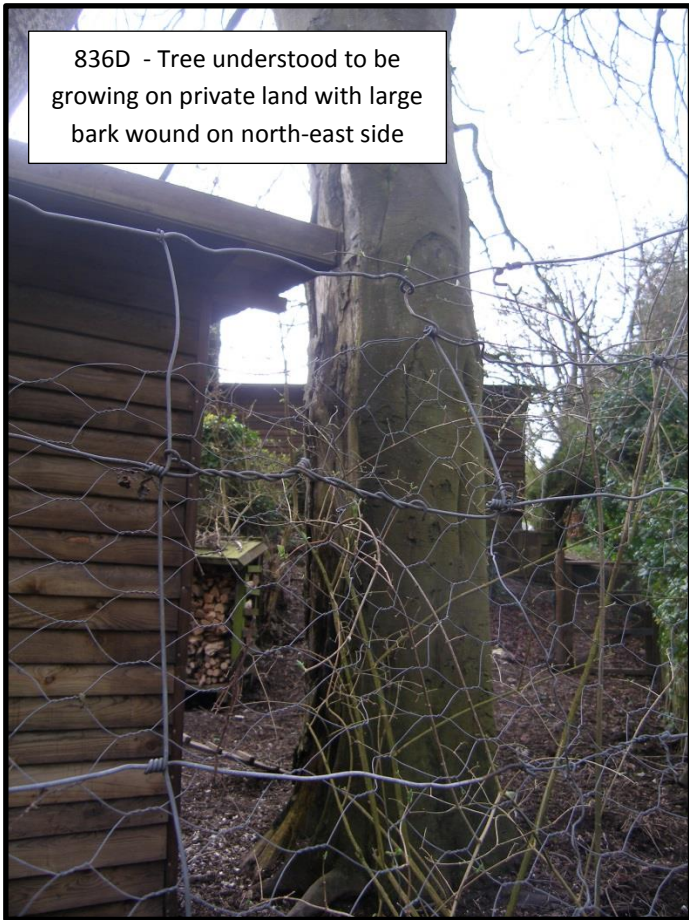
836D - Tree understood to be growing on private land with large bark wound on north-east side
